Preservation Assessment of the McKinney Engineering Library
University of Texas at Austin
Helen Kuncicky
Protection and Care of Records Materials
Spring 2008
Instructor: Karen Pavelka

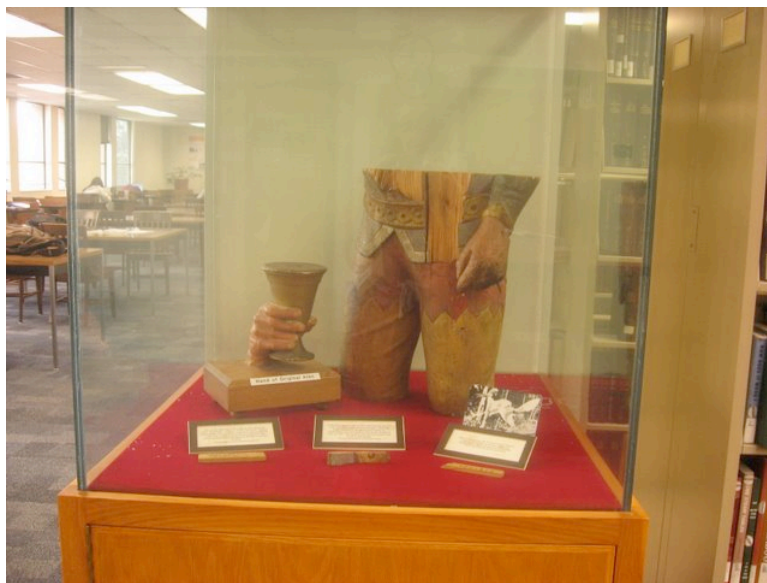
Figure 1: Artifacts displayed in case

The McKinney Library intentionally leaves the collection of historical materials to other libraries with more special-collections oriented missions. The exception to this is an assortment of artifacts housed in the library. Some of these are donations to the library that are put on display, however these items are typically discarded when the display is changed. The few historical artifacts on permanent display do not belong to the engineering library, but are actually the property of the university. These include two statues of Alec, the engineering school’s mascot (one of which is in pieces), and two metal trophies in the conference room (see figures 1 and 2). During our site visit, it was noted that one of the trophies is very tarnished and the other had some trash inside it.

- The artifacts, even those that do not belong to the library directly, are in the library's care and should be maintained accordingly. All artifacts should be cleaned of dust and debris on a regular basis. The artifacts displayed and stored in the library should be catalogued in some manner.

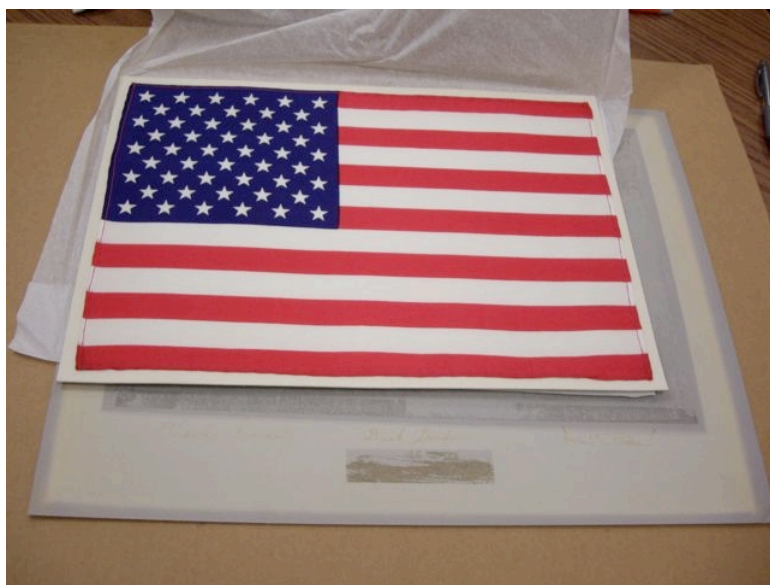
Figure 3: Moon flag waiting for conservation treatment

There is also one item that is of special value to the library; a U.S. flag that has been to the moon, donated by astronaut Alan Bean (see figures 3 and 4). Conservation treatment has been arranged due to fading of the signatures on the flag's support. The flag will be re-housed and put back on display in the library.

- It is excellent that the flag is already expected to undergo conservation treatment. It is recommended that the treatment include placement under a UV filter. The glass in the frame can either be replaced with UV-filtration glass or coated with UV-filtration film. This should be specifically requested as part of the conservation treatment.

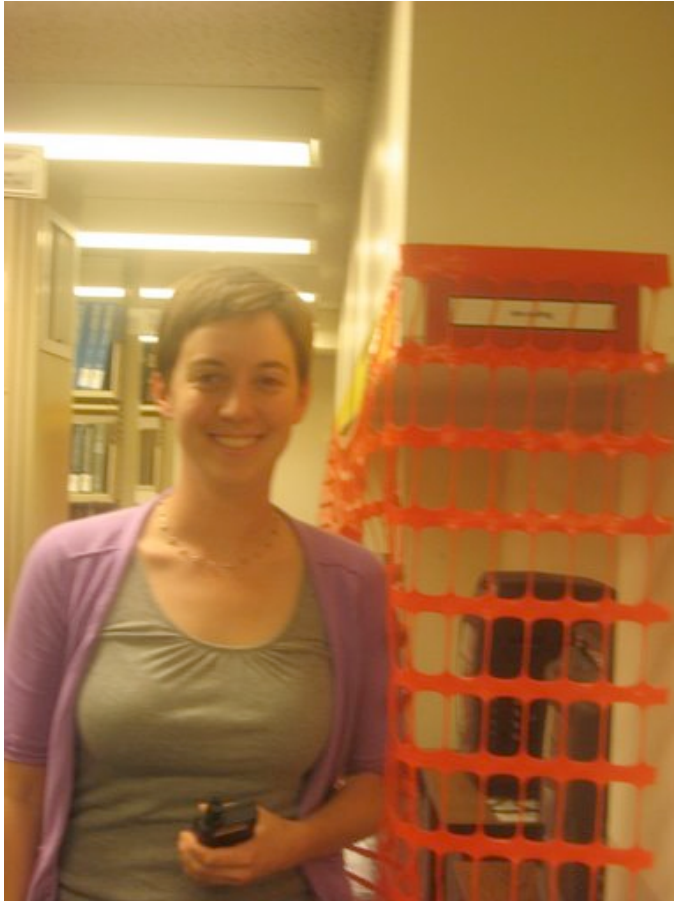
Figure 7: Visual barrier on low-hanging corner

There is a low-hanging, potentially dangerous sharp corner sticking out at head level on the mezzanine level, which has an orange construction-zone web over it to keep people from running into it. This visual barrier was designed in-house to prevent injury of patrons or staff (see figure 7).

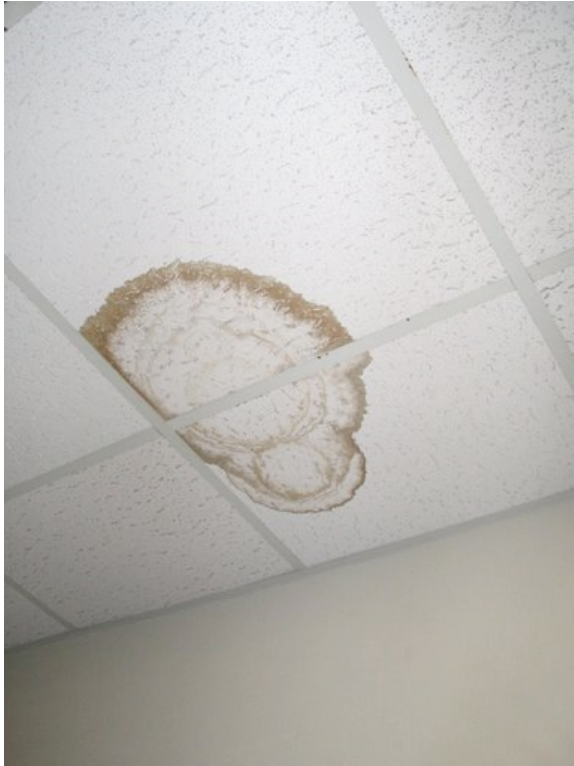
Figure 8: Damage from leaks in upper floor bathrooms

Since the new roof was finished, there have been no reported leaks coming from the roof. However, there have been small leaks due to plumbing incidents, which have caused damage to the ceiling tiles (see Figure 8). The toilets and sinks have been replaced on the first floor,

however plumbing issues still exist on other (higher) floors. It was expressed during the site visit that leaks have not always been reported, especially before the roof was fixed when they occurred frequently. The staff would simply put plastic over the items and containers in place to catch the dripping water.

- The fact that leaks were not reported for many years prior to the flood incident is of concern. All leaks and other facilities issues should be reported promptly. In addition, the library would do well to build a stronger relationship with the facilities staff.

6. The fact that leaks were not reported for many years prior to the flood incident is of concern. All leaks and other facilities issues should be reported promptly. In addition, the library would do well to build a stronger relationship with the facilities staff.

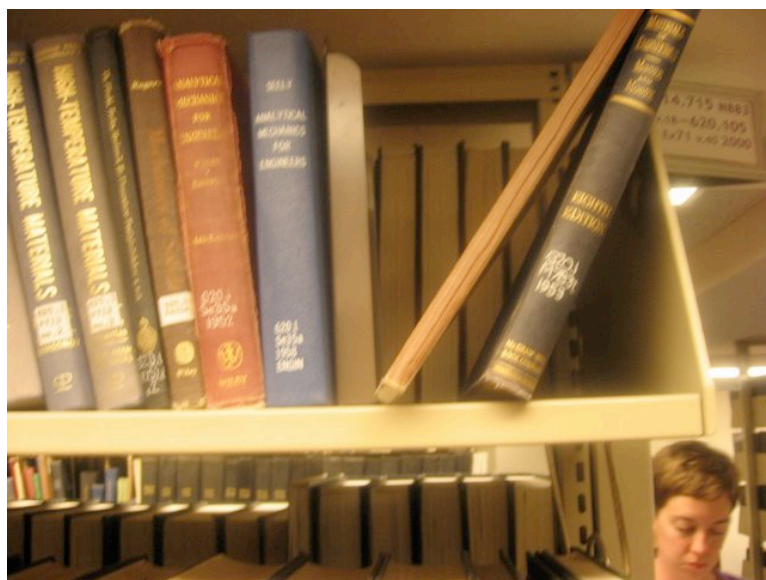
Figure 9: Books leaning on shelves

The stacks are a true stacking system, with metal supports running through the first and mezzanine levels that are supporting not only the shelves but the mezzanine level as well. There is about 6 inches of space between the tops of most books on the top shelves and the ceiling on both floors. Some of the shelves in the outer area are not stacking, but are simply free-standing shelves. These rock back and forth when pressure is exerted on them. Some of the books are leaning on the shelves, although there are hanging metal bookends to support them upright (see Figure 9). The staff does routinely go around and re-shelve items in correct order, and make sure they are shelved correctly. There is a small room next to the periodical room which houses the microfilm collection. These are stored in metal cabinets. When on book trucks, books are stored fore edge down for ease of use and to prevent them from falling over.

- The free-standing shelves that sway should be replaced or further supported immediately, as this is a potential danger to patrons and staff. The easiest solution would be to extend brackets onto the ceiling to support the tops of these shelves. If necessary, the shelves could also be replaced with ones that are wider and thus have a sturdier base. However, this would reduce some of the space between the shelves and in the outer corridor.

1. The free-standing shelves that sway should be replaced or further supported immediately, as this is a potential danger to patrons and staff. The easiest solution would be to extend brackets onto the ceiling to support the tops of these shelves. If necessary, the shelves could also be replaced with ones that are wider and thus have a sturdier base. However, this would reduce some of the space between the shelves and in the outer corridor.
